F-5F Mat. 4502

Repair Proposal

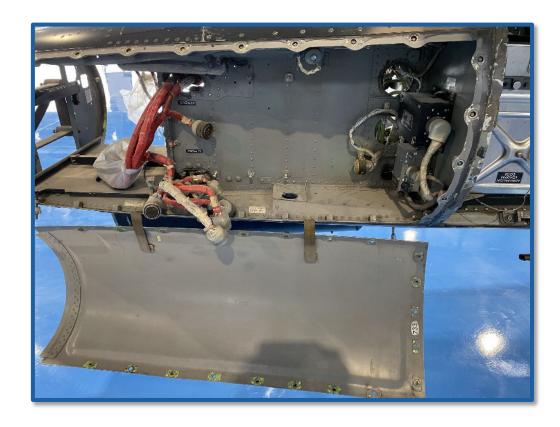
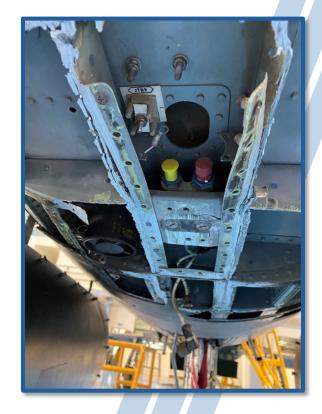
Current Condition of F-5F Mat. 4502

Major damage to lower forward fuselage but damage is limited to FS 47.5 to 87.5. There are no signs of damage past FS 87.5. The aircraft is fully repairable.

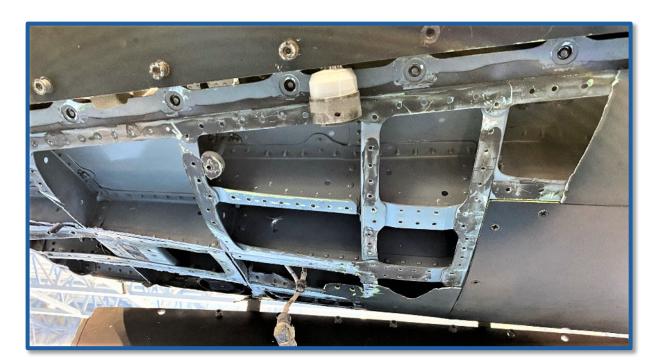
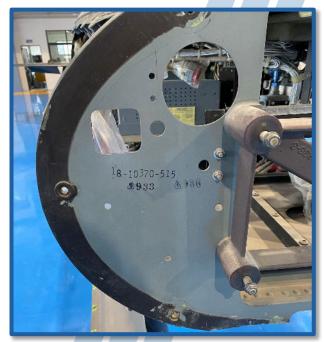
Current Condition of F-5F Mat. 4502

The damage requires that the entire lower section of the fuselage FS47.5 to 87.5 be replaced with new parts.

The upper section of the assembly is undamaged. The bulkhead at 47.5 needs replacement
