# REGULATOR TENSION, CABLE QUADRANT, HORZ STABILIZER

Repair & Refurbish

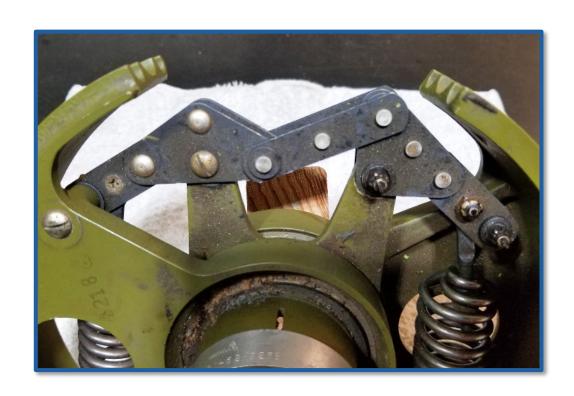
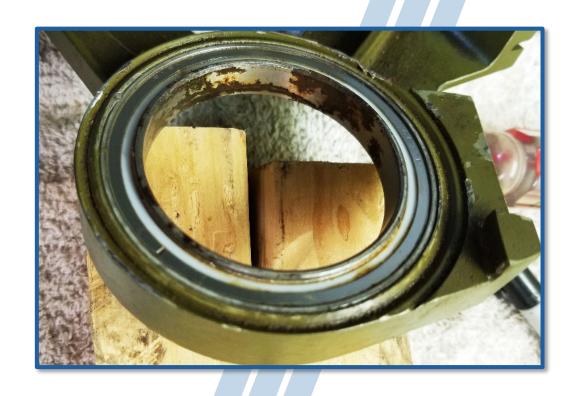
Both bearings were heavily rusted and seized.

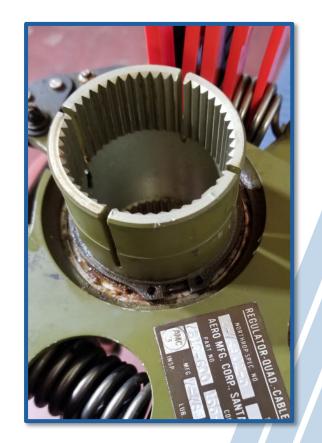
The shaft assembly was lightly corroded.
