COC Leading Edge Flap Repair

F-5 Leading Edge Flap Reskinning and Repair

COC Aerospace has developed a highly cost-effective method of reskinning and refurbishing Northrop F-5 Leading Edge Flaps. P/N 14-27200-509 / -510

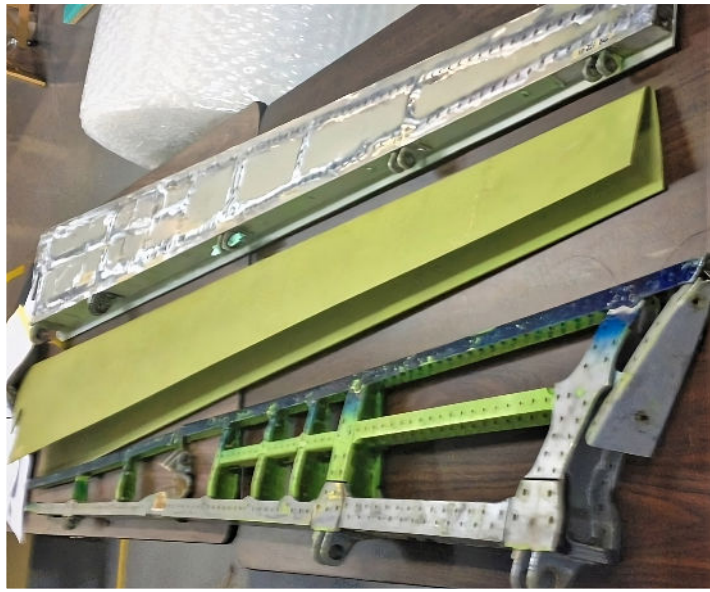
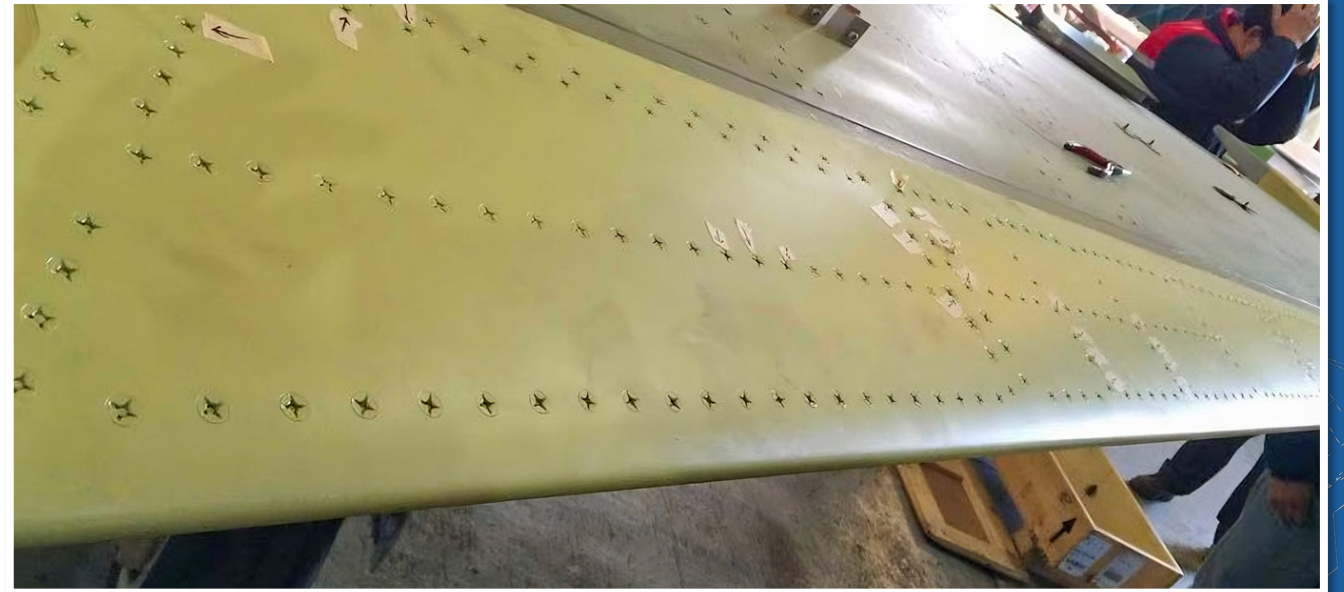
Measuring Dimensions

Using High-Tech Metrology technologies like photogrammetry, COC measures the individual dimensions of each LE Flap we repair. Each LE Flap is slightly different – fastener hole locations vary from one part to the next, sub-components are different from one assembly to the next.

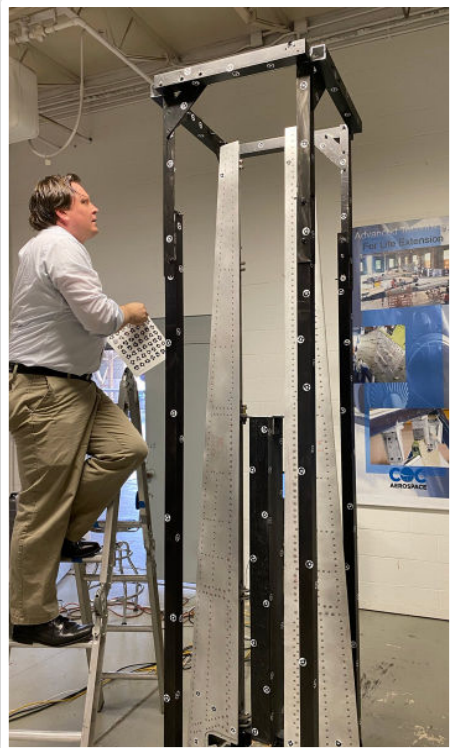
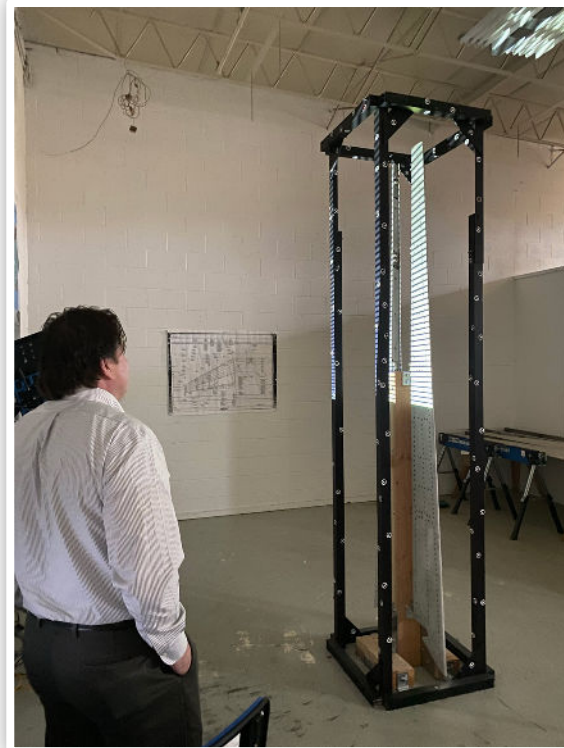
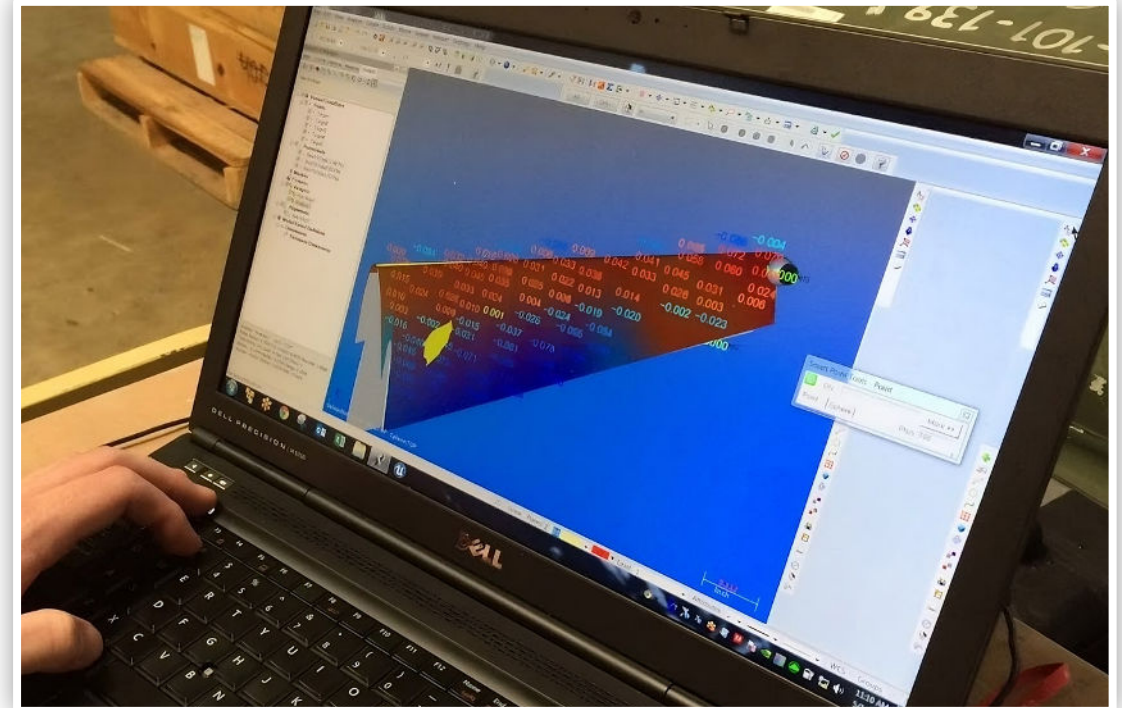
Comprehensive Inspection Methods & Procedures

- ✈ Visual inspection of the LE Flaps
- ✈ Media cleaning of the complete assembly
- ✈ Thorough, organized inspection using specialized procedures developed here at COC
- ✈ Visual inspection in accordance with NAVAIR 01-1A-1 and related T.O.s and engineering documents
- ✈ Ultrasonic Inspection performed by our NDT Inspector

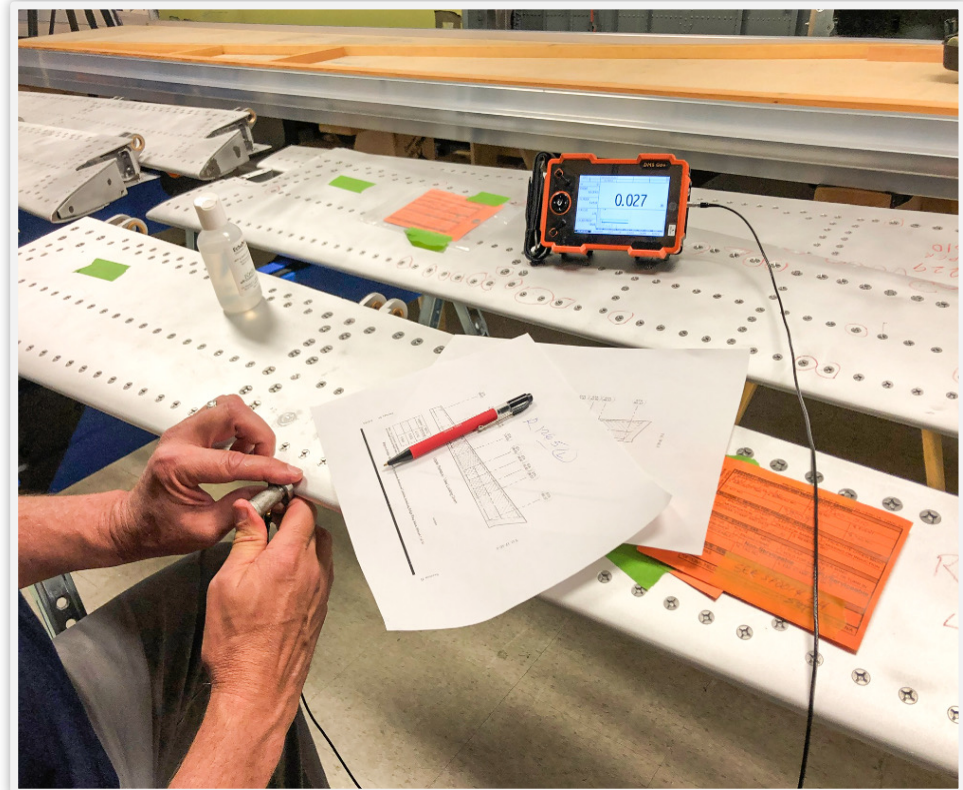
Inspection Methods & Procedures

For more detailed information on our inspection process, view the [‘Inspection White Pages’](#) document here.

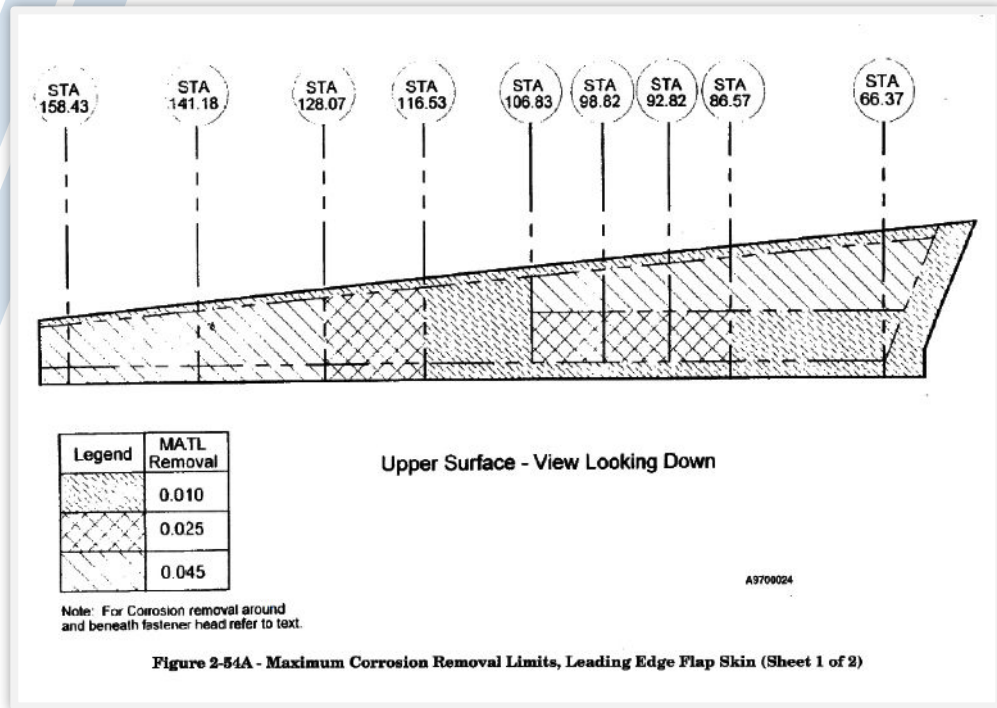
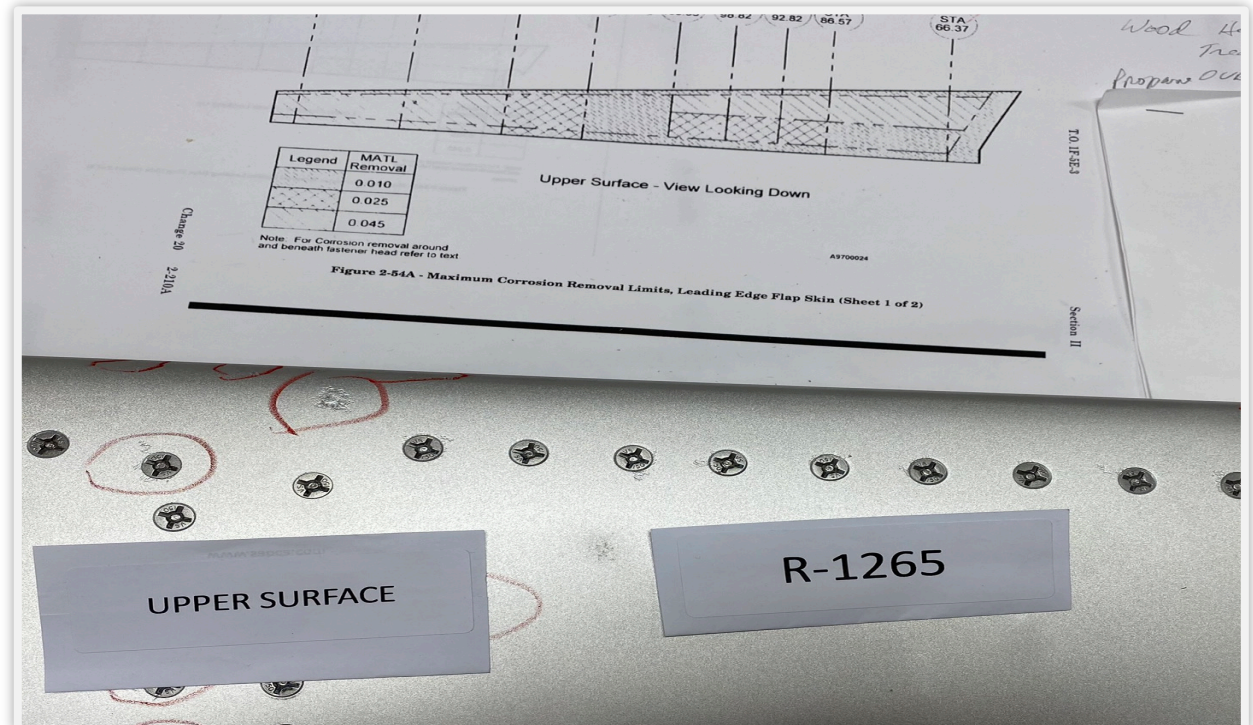
Maximum corrosion Removal Limits Diagram for LE Flap Skin

✈️ We enlarged these images 'poster size' to 105.5" so that the Maximum Corrosion images were the same size as the LE flaps we are inspecting.

✈️ These posters are secured onto our large work-table which makes it easy and organized to see the different size hash marks listed on the Legends Reference Tables.

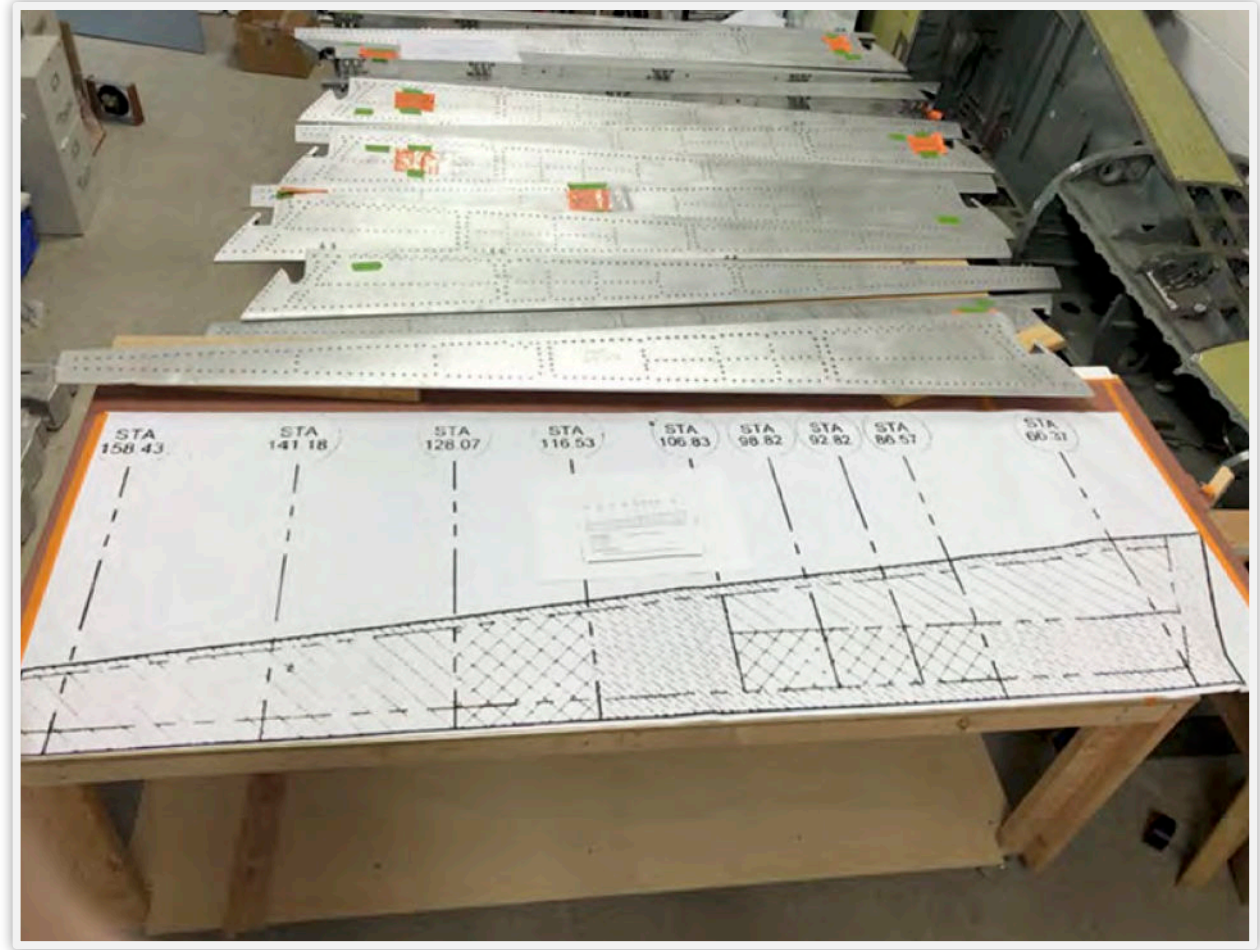
Inspection Case Study

COC received a total of 15 LE Flaps for evaluation, nine (9) are RH – 509 and six (6), LH. There is one flap, R-1042 that is -508, RH.

- Determined whether the LE flaps should be repaired by replacing the main skin, part number 14- 27201-9 and -10, or whether the flaps should be refurbished.
- Recommended improved and more comprehensive procedures for inspecting LE Flaps on all Navy F-5Ns.

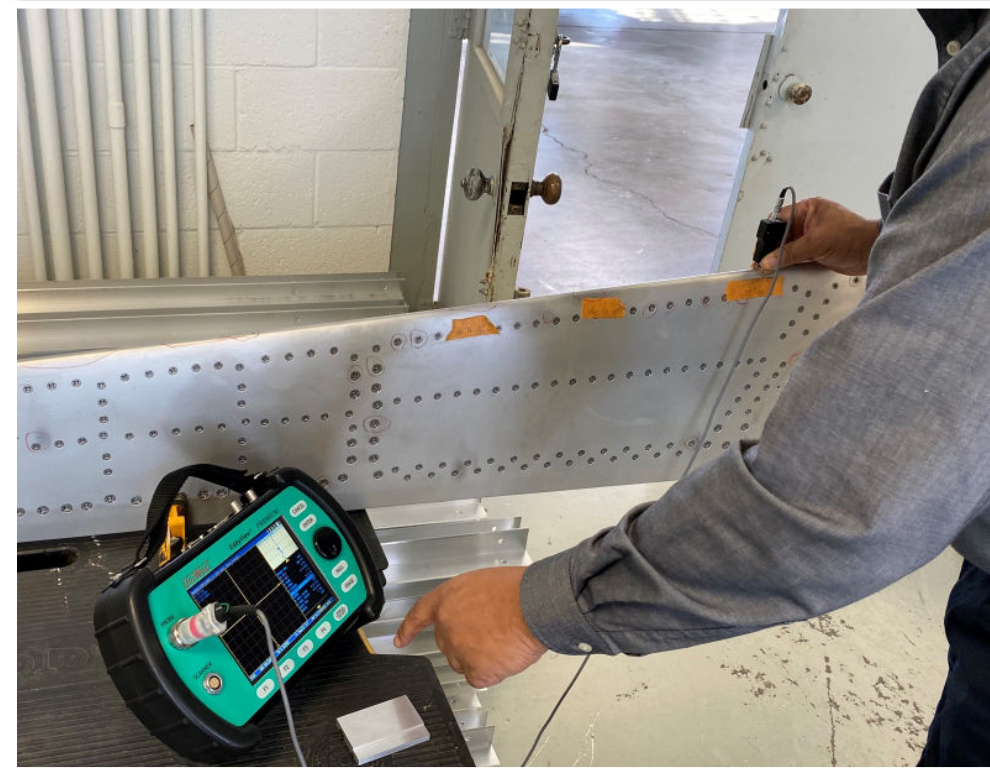
Inspection Case Study

The inspections performed by COC and our level III NDT Inspector showed a pattern of wear and corrosion that seemed to be the same on all the flaps inspected.

- Leading Edge skins are formed from 7075 aluminum sheet, 0.125". In order to obtain the bend radius at the leading edge, the 0.125" material is tapered from 0.125" to 0.057" at the wing root to .025 at the tip.
- The limits of material removal, or material wear and corrosion, is 0.010" at the extreme leading edge. The fact that the material is tapered down, 0.057" to 0.025", there isn't very much leeway for wear and corrosion.

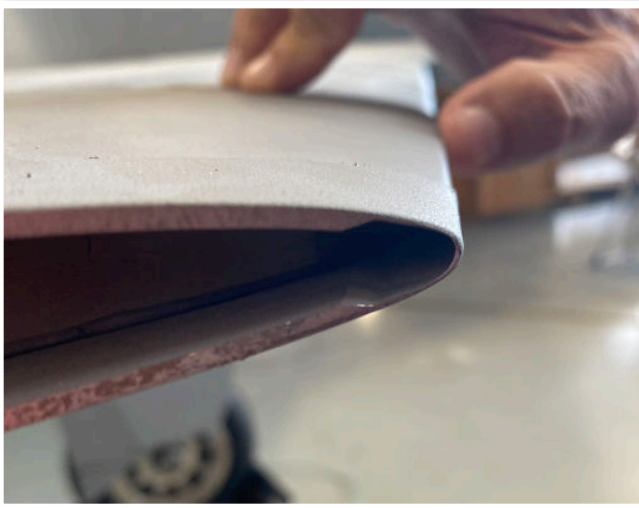
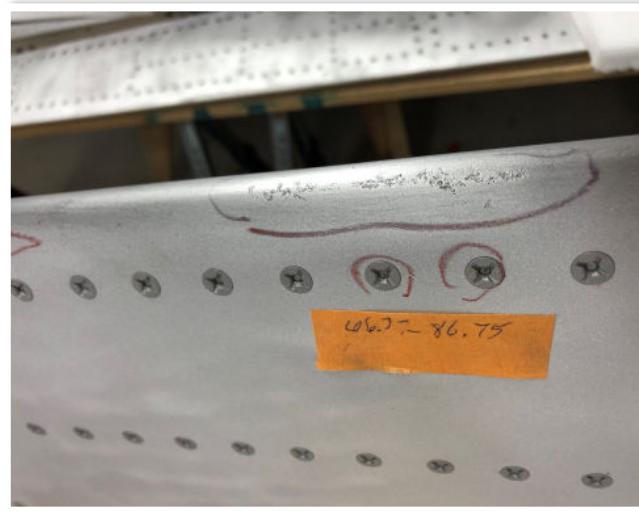
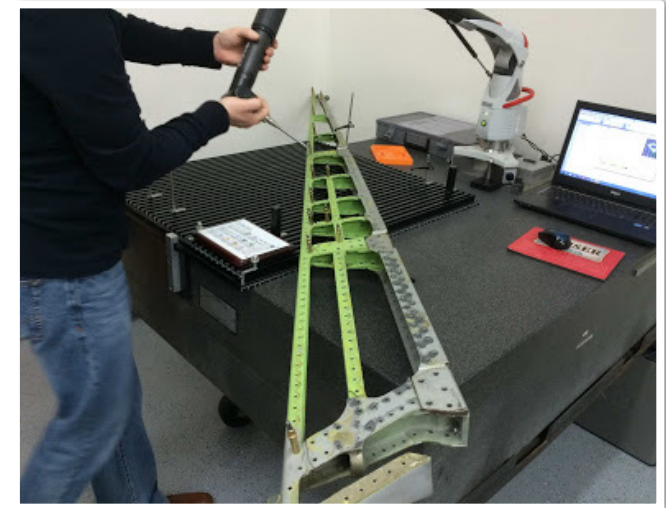
Disassembly and Development

- ✈️ By 3D measuring the fastener hole locations with photogrammetry, each LE Flap fastener hole can be located to NIST calibrated 0.002” of an inch.
- ✈️ The 'point-clouds' are converted to CAD. This data is programmed into our CNC mill. Then the fasteners are machined out
- ✈️ This saves time and eliminates possible part damage that can occur with manual fastener removal.

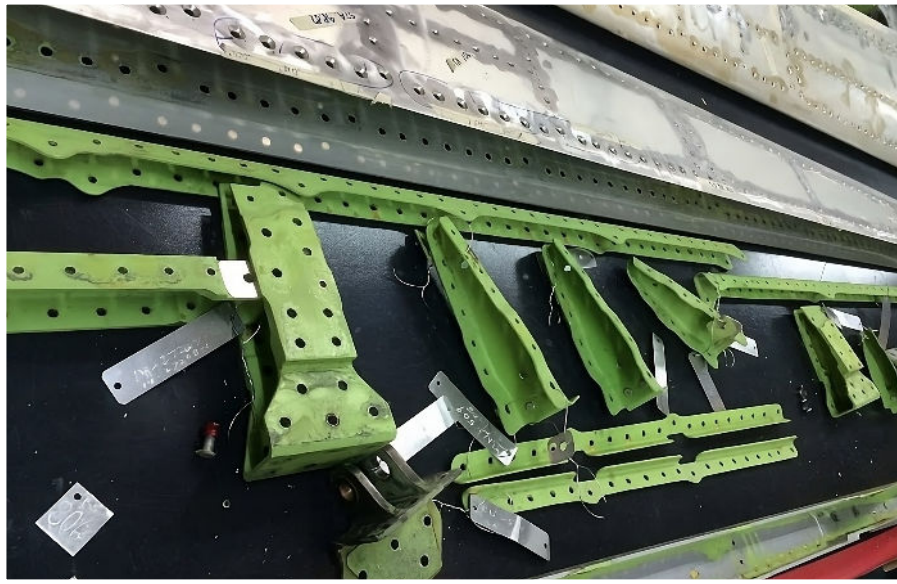
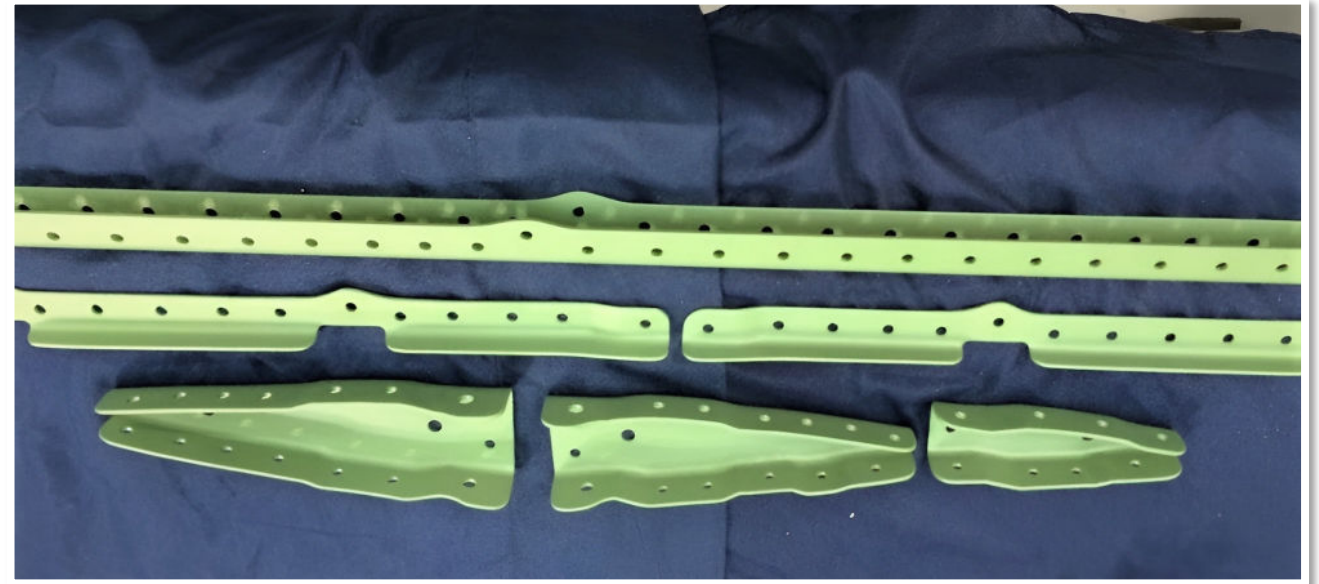
Reassembly and Completion

✈️ Parts like the Skins are replaced with new parts and then re-assembled with all new hardware.

✈️ Aircraft are returned to flight service four (4) times faster at a savings of over 50% of replacing flaps with new assemblies.
